Torrey Pines Utility & ADA Improvements Project

Torrey Pines State Natural Reserve

Project Issues:

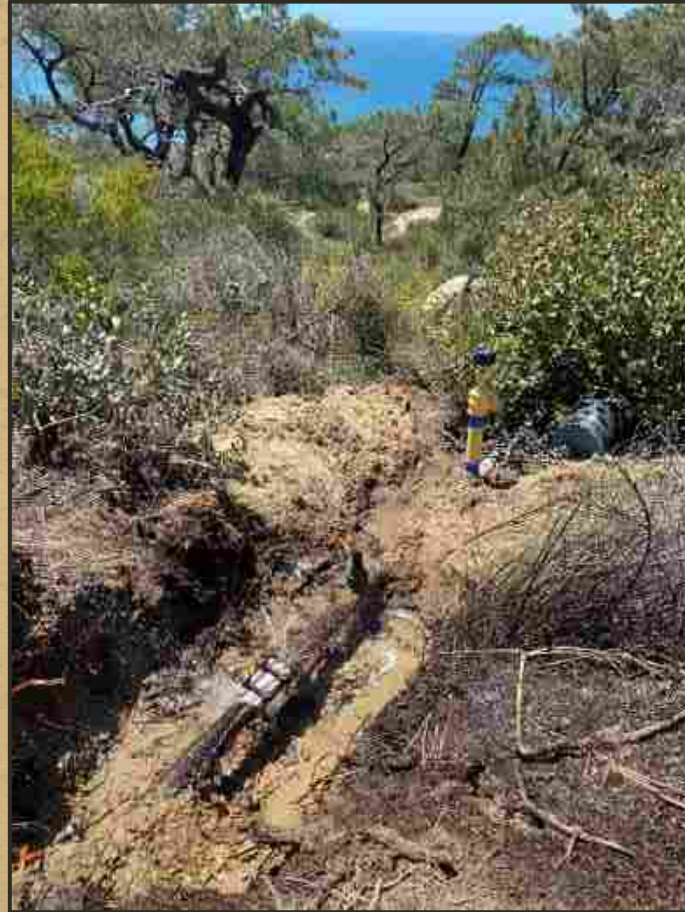
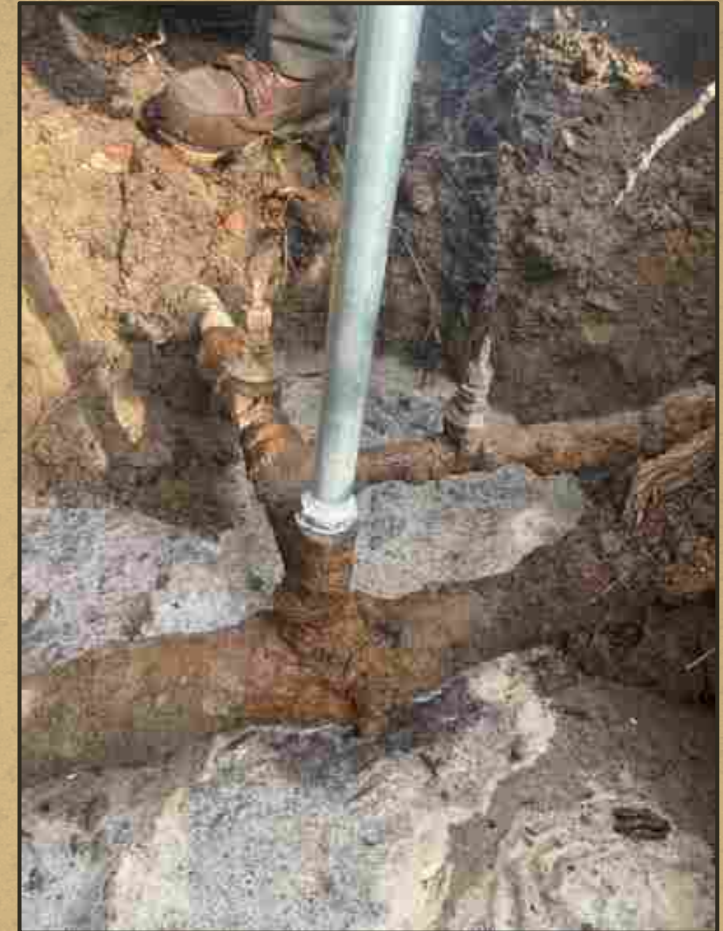
Existing Conditions:

- Failing potable water lines
- No dedicated fire water line
- Only telephone communications, no internet/broadband lines
- Deficient leach fields/sewer system

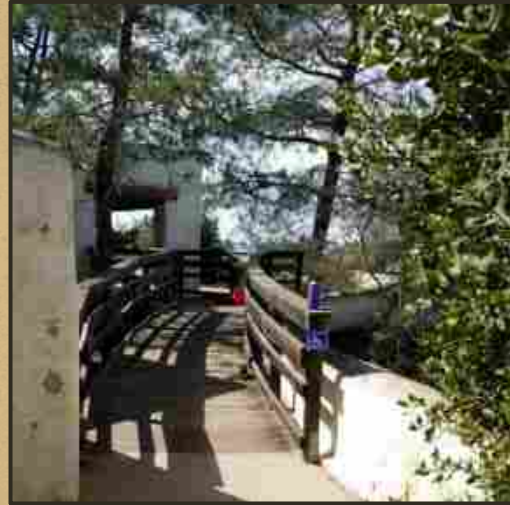
Ramp is non-compliant and not to current code

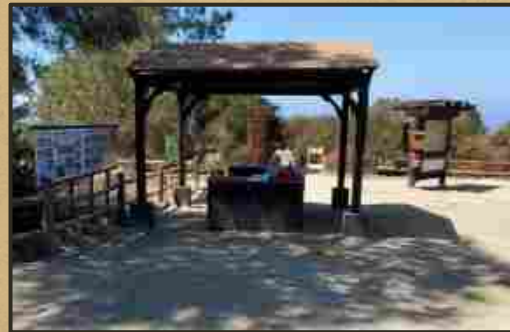
Non-compliant trailhead and kiosk

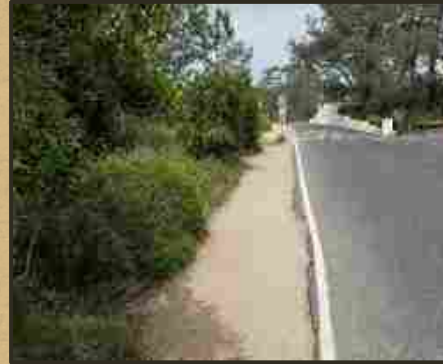
Non-compliant trails and walkways

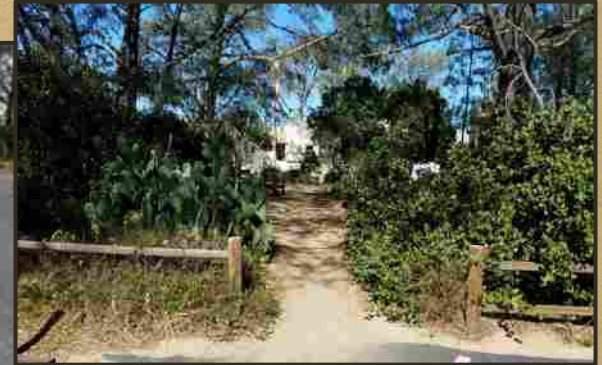
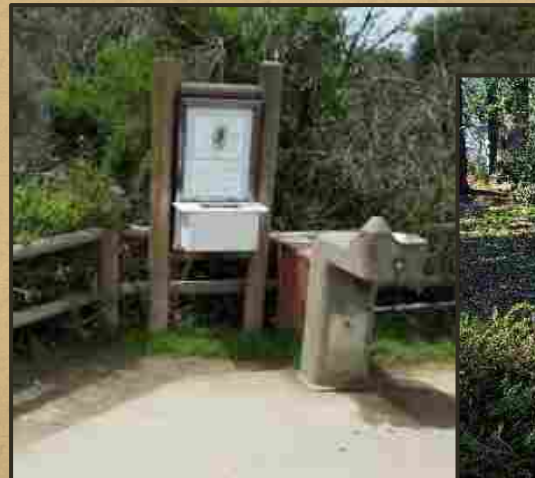
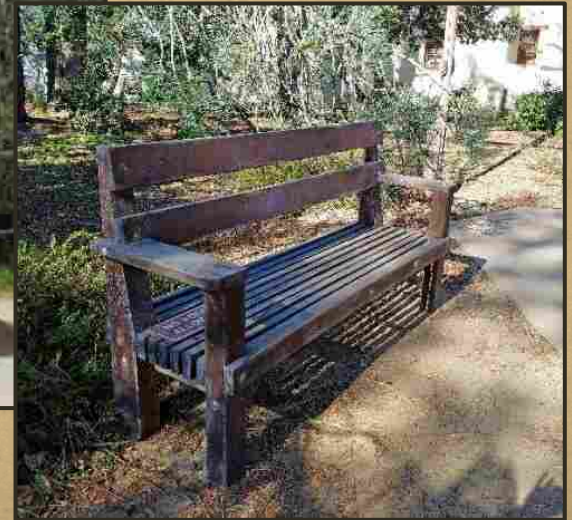
Non-compliant site furnishings

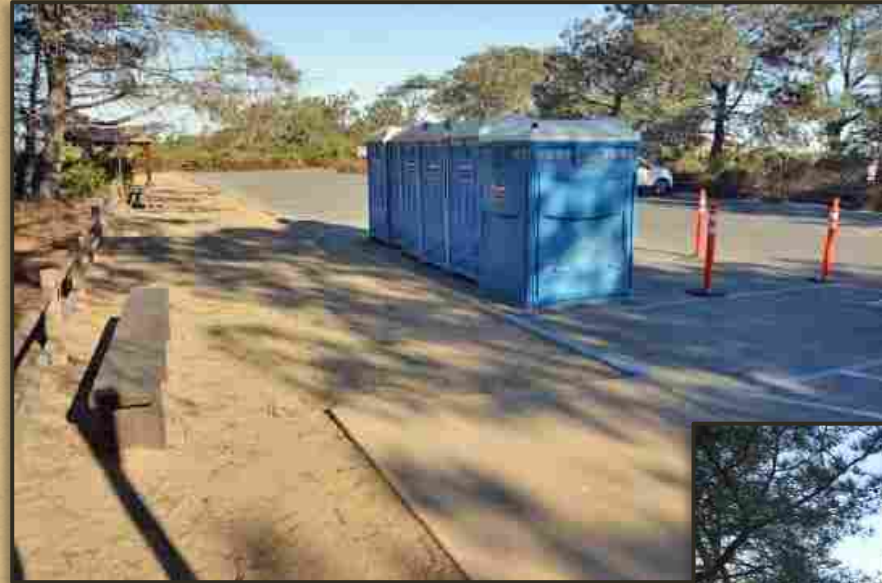
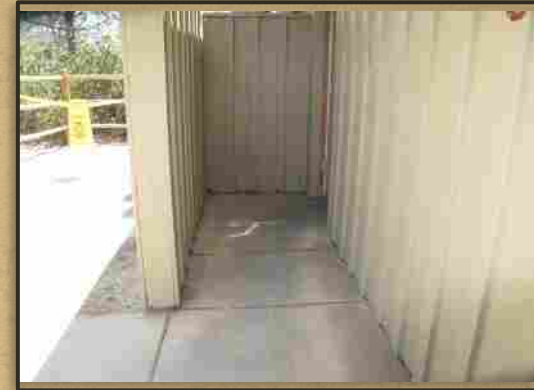
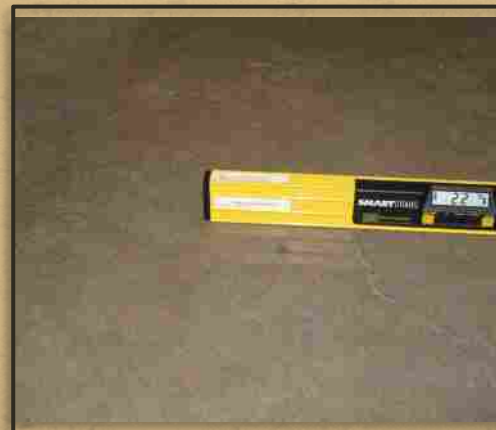
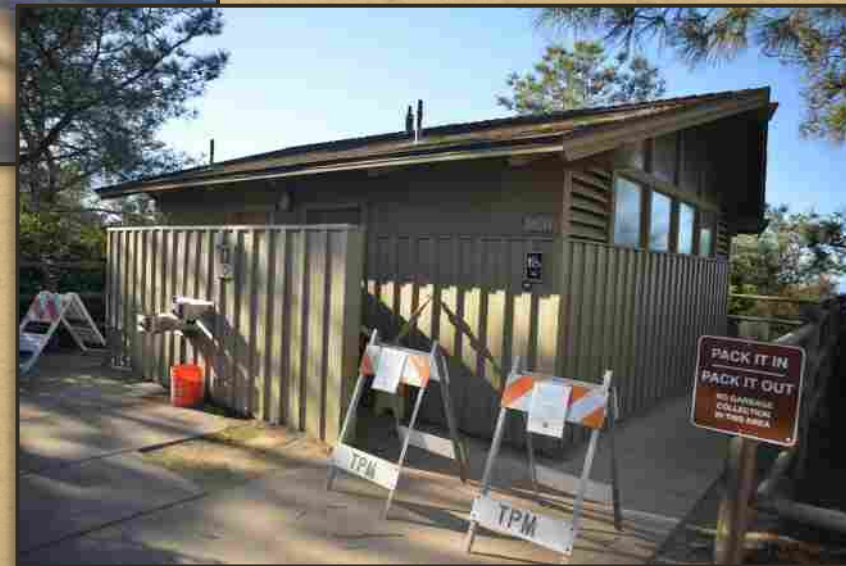
West Parking Lot Restroom

- Closed, non-functioning, and inaccessible restroom
- Portable toilets only available to visitors
- Non-compliant restroom entrances
- Non-compliant floor slopes
- No ADA-compliant toilet stalls

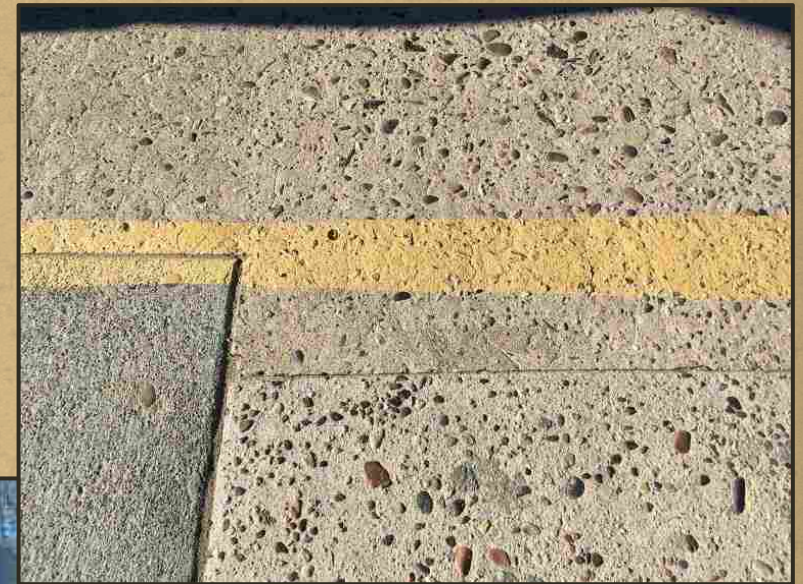
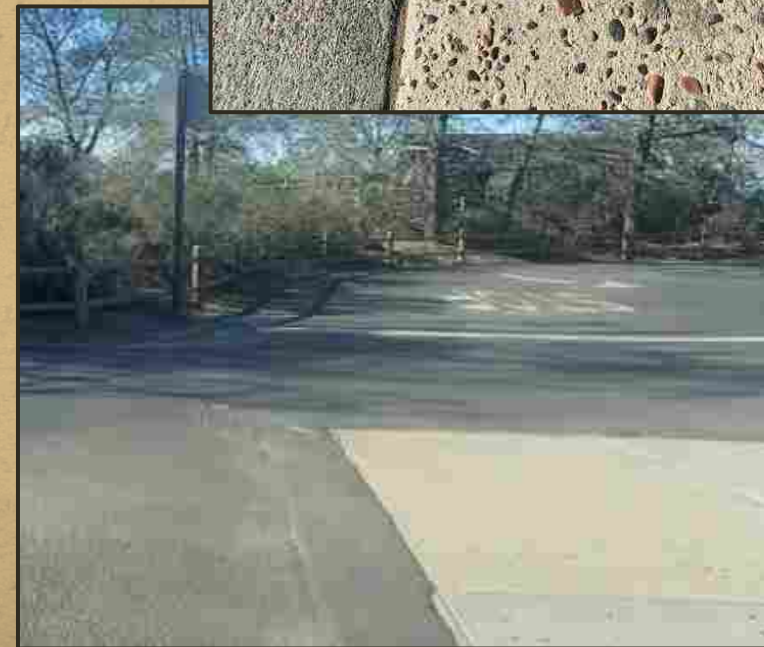
Project Components:

- Install New Utility Infrastructure
 - Fire water
 - Potable water
 - Electrical
 - Communications
 - Sewer
- Abandon utilities within environmentally sensitive areas and trench new utilities in roadway
- Demolish existing restroom at West Parking Lot
- Replace current patchwork of concrete road with in-kind concrete, reflective of historic road surface

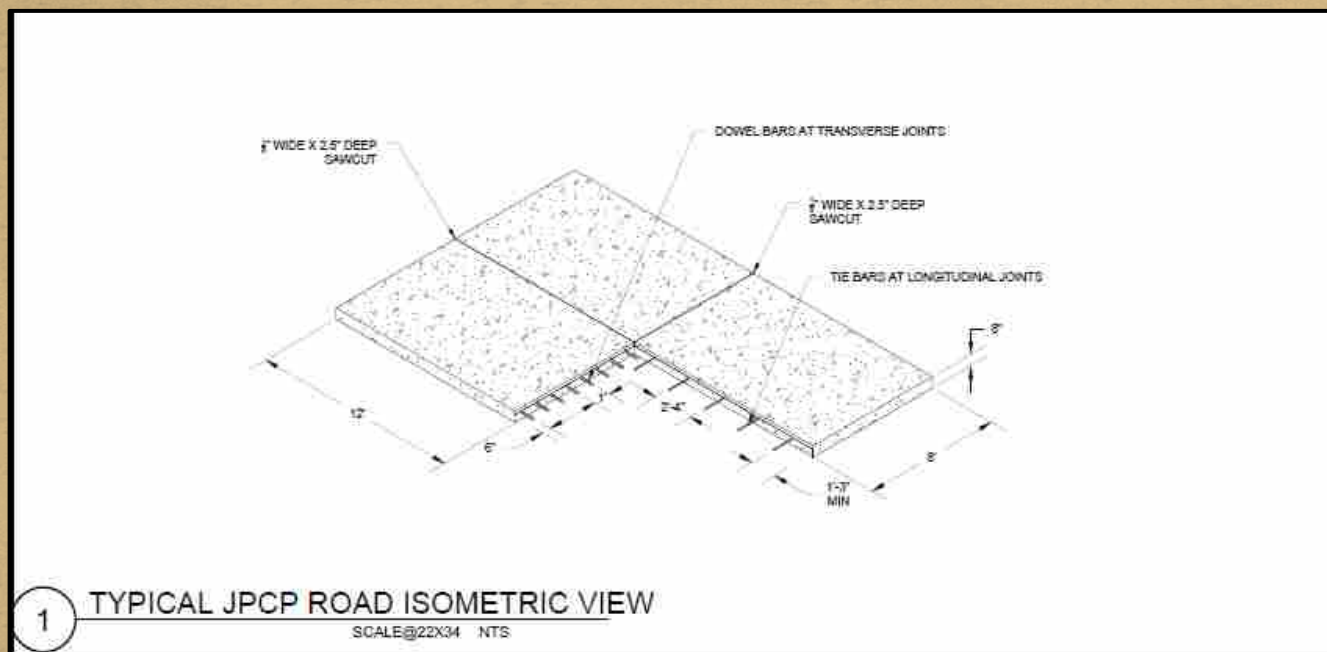
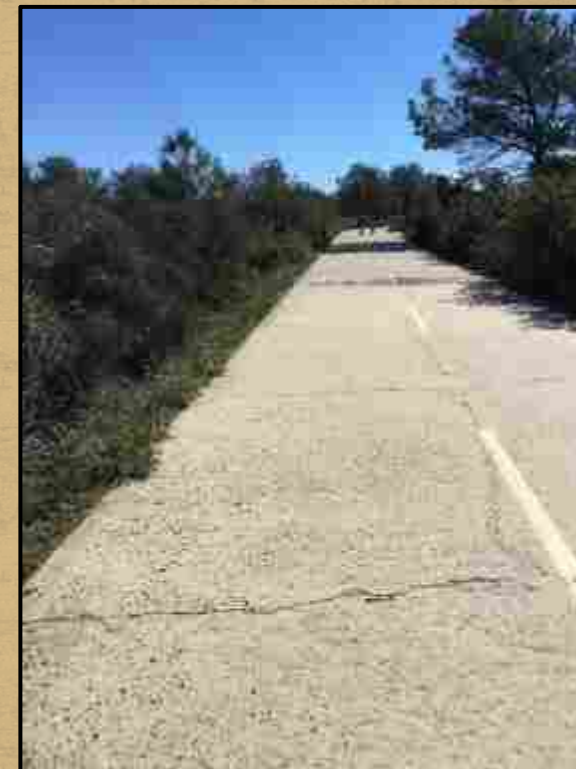
Utility Improvements (Phase I)

- Replace existing road with new Jointed Plain Concrete Pavement (JPCP) to minimize and control cracking
- New JPCP similar in color and aggregate to historic matrix

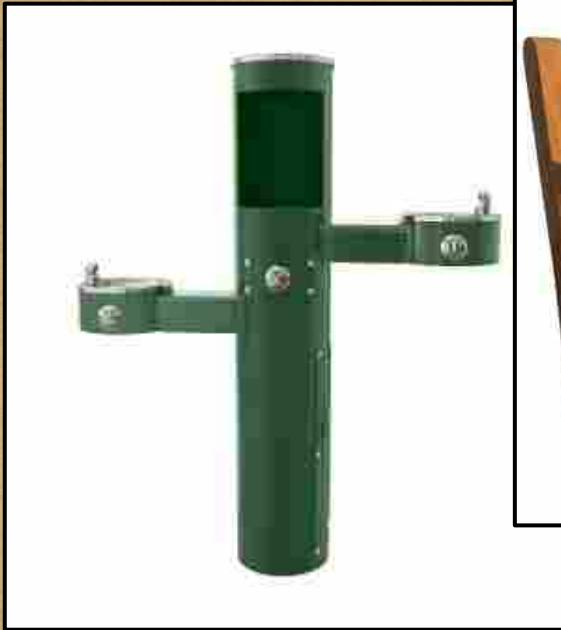
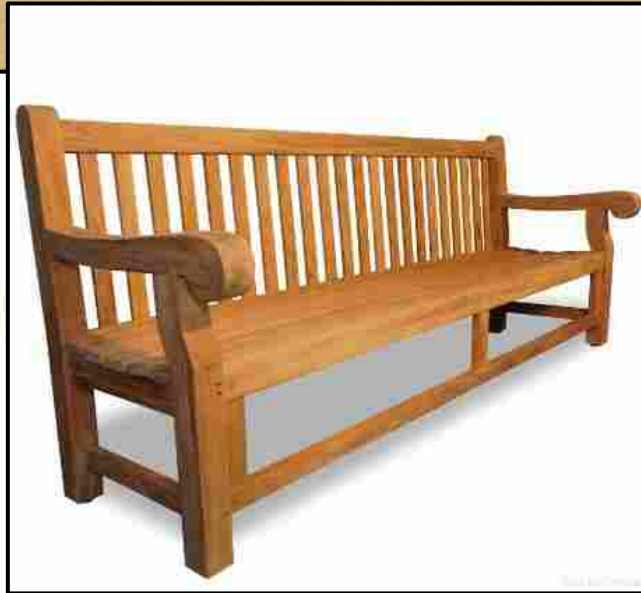
- Complete construction of accessible restroom at West Parking Lot
- Provide compliant parking stalls at Visitor Center and West Parking Lot
- Improve pedestrian circulation between the Visitor Center, West Parking Lot restroom, and trailhead

- Provide compliant benches and drinking fountains
- Install doorbell for entrance to Visitor Center for use during inclement weather

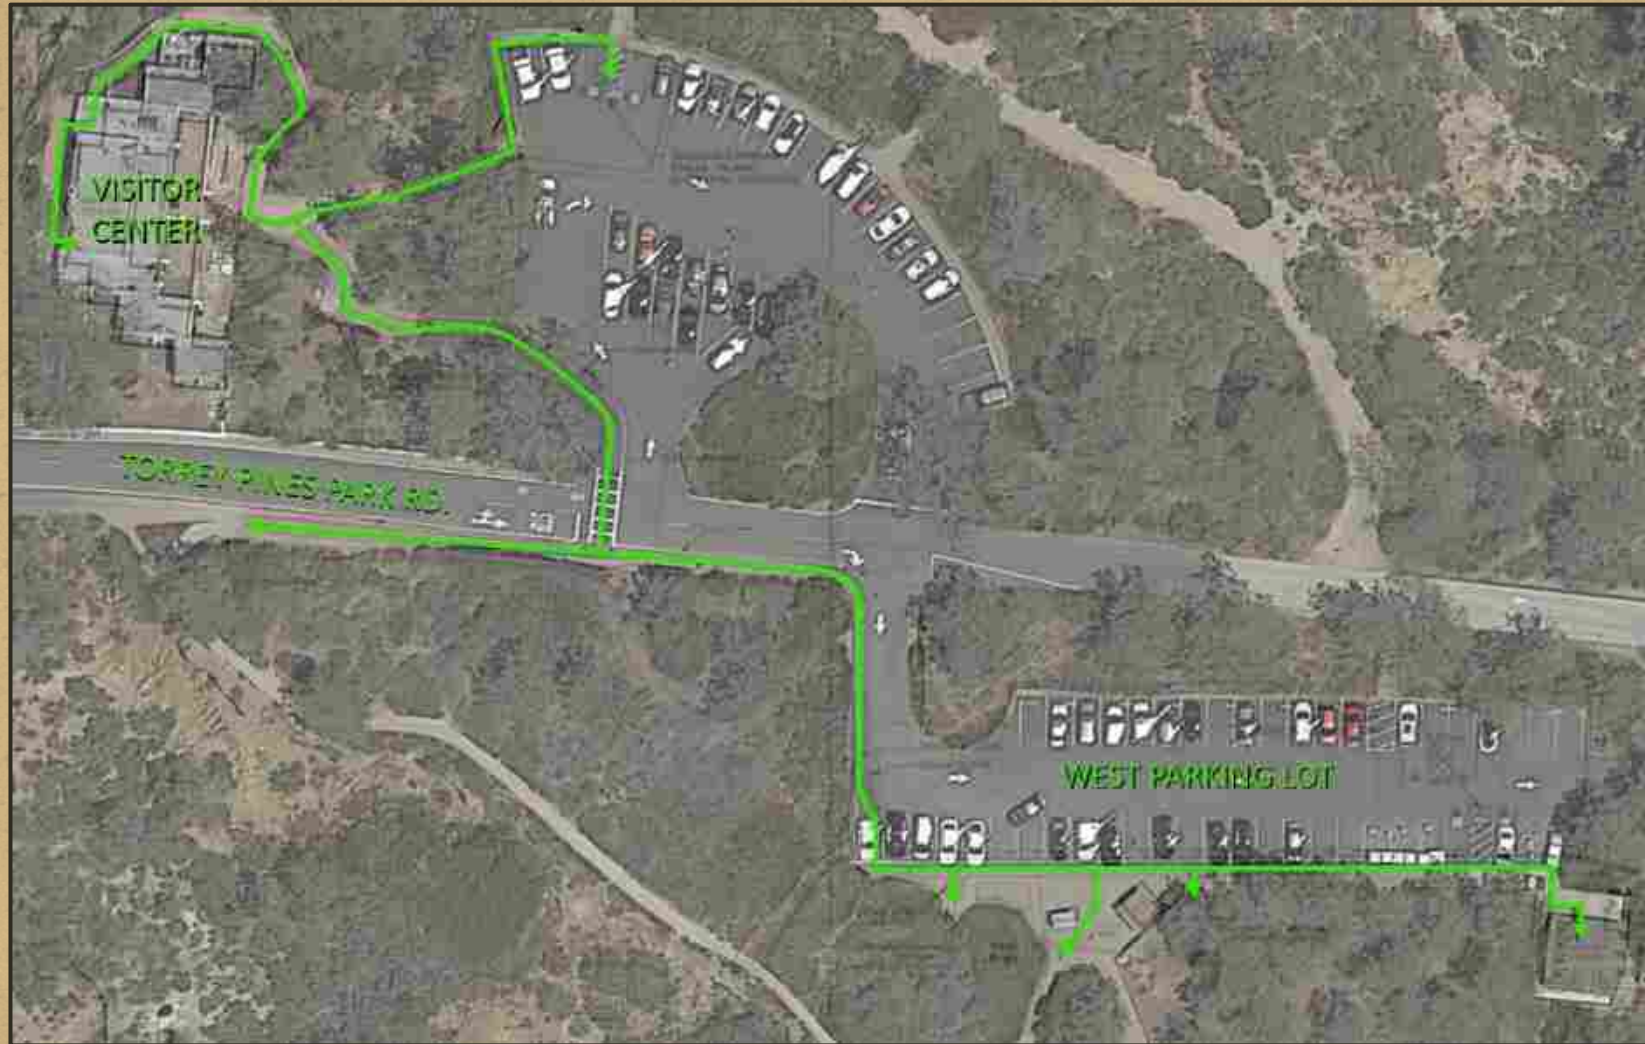
Accessible Path of Travel

- Provide designated paths of travel from the Visitor Center to accessible trails, trailhead, & West Parking Lot restroom

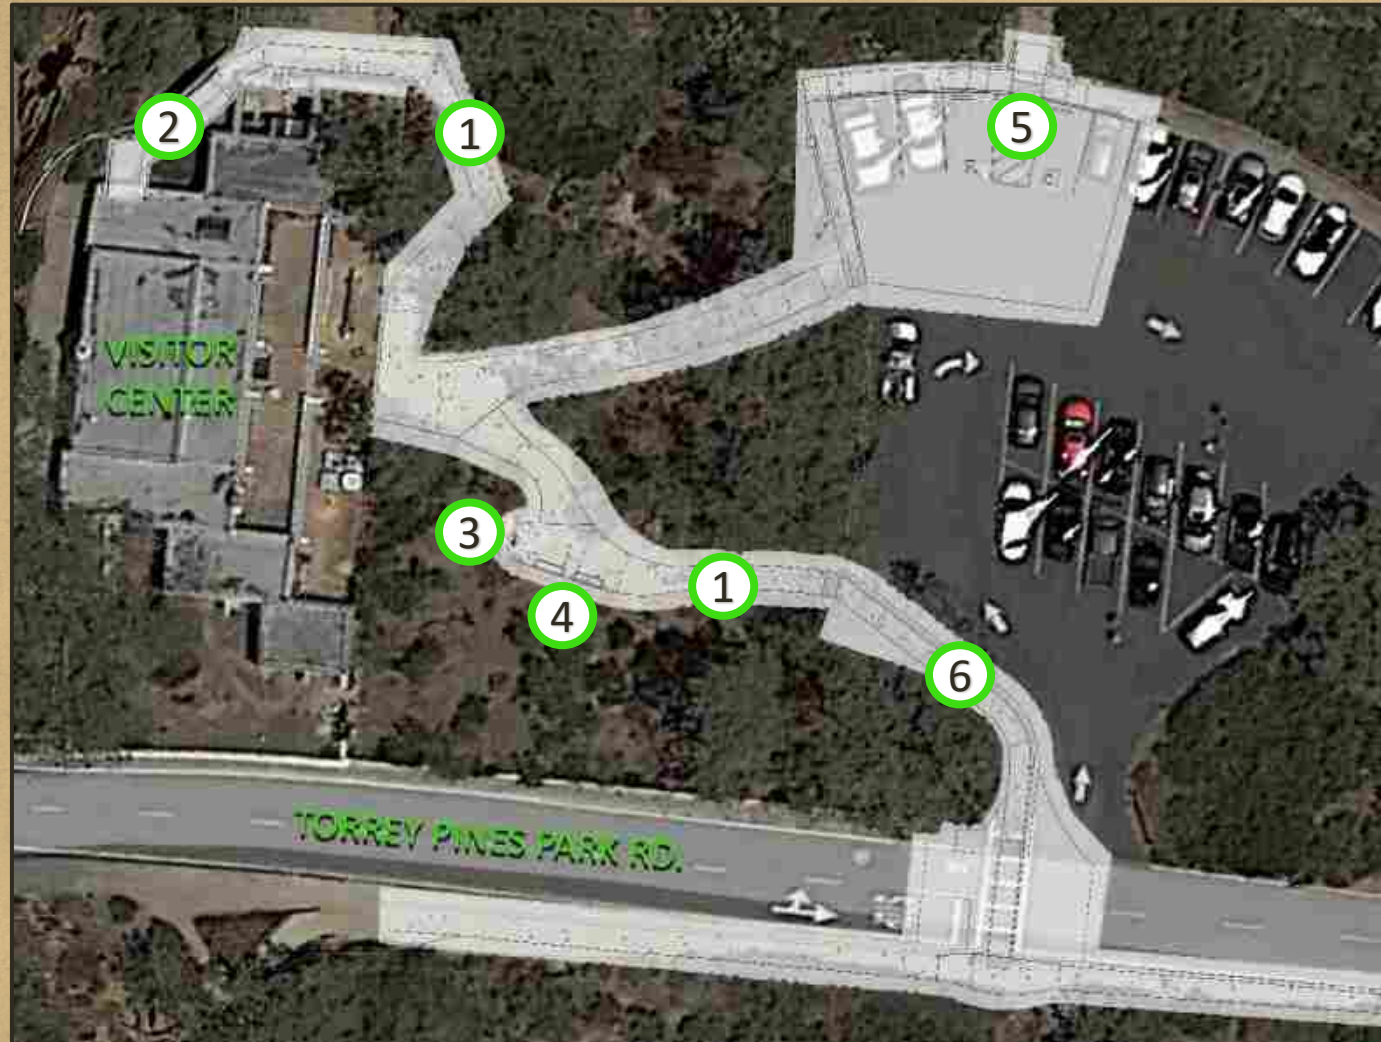
Visitor Center

1. Improve pedestrian walkways with accessible slopes and surfaces
2. New ramp to meet accessibility and code requirements
3. New accessible drinking fountain and water bottle filling station

4. New accessible benches
5. Improved, accessible parking spaces to meet compliant slopes
6. Accessible path of travel to accessible trail and West Parking Lot

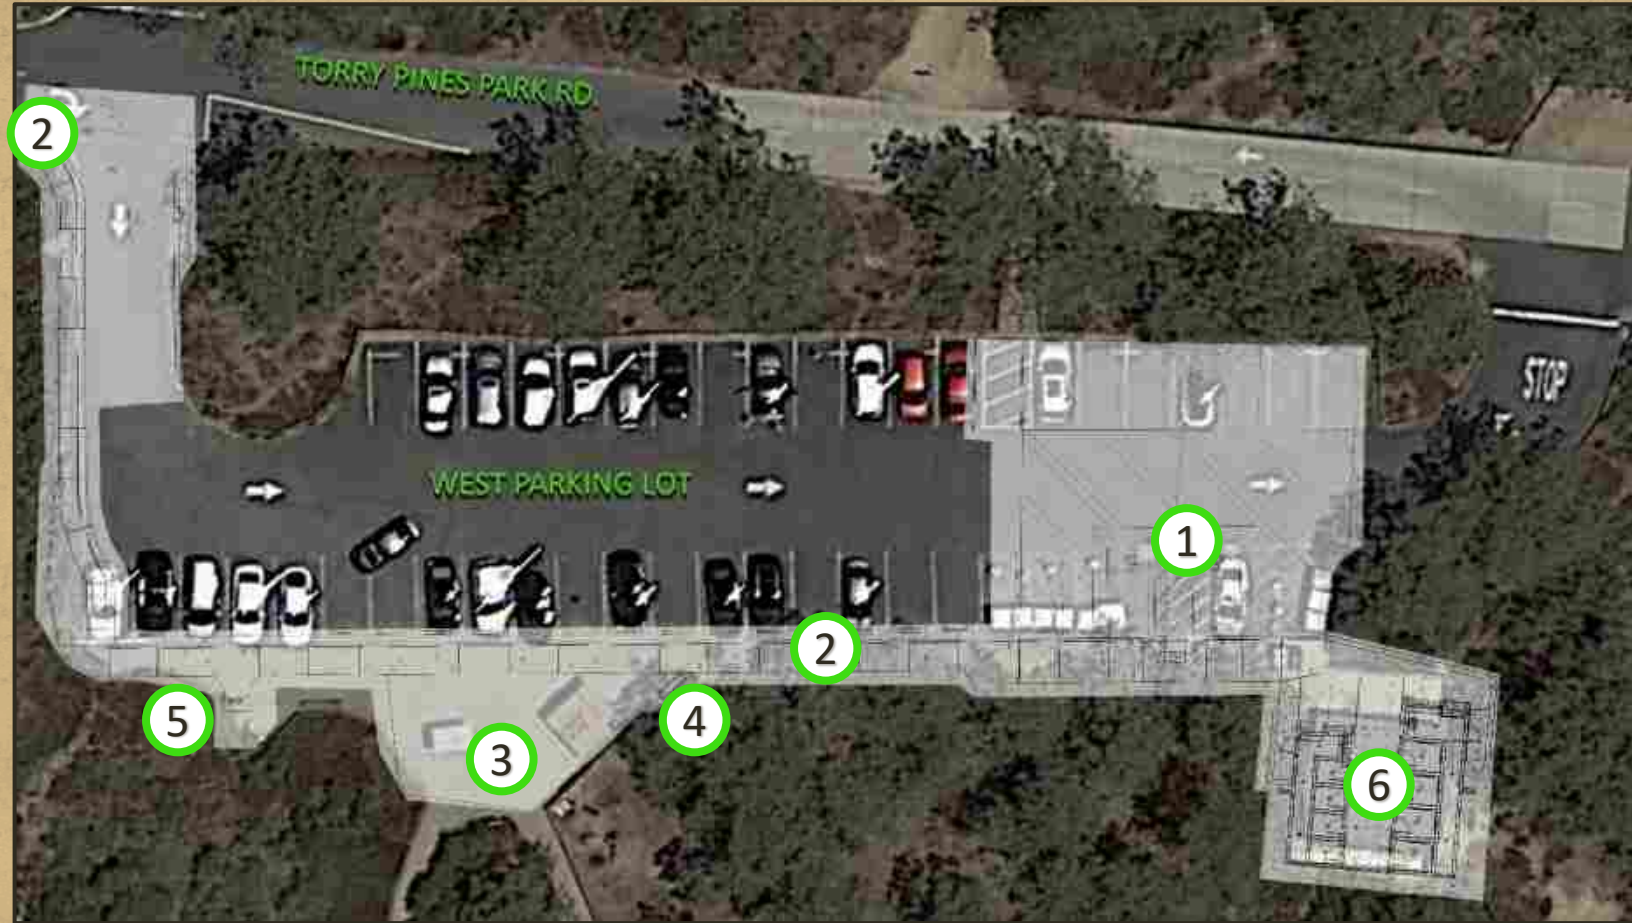
West Lot, Trailhead, & Restroom

1. Improved accessible parking spaces to meet compliant codes
2. Designated compliant pedestrian access to trailhead and West Parking Lot restroom from the Visitor Center and trail
3. Improved, accessible surface at trailhead
4. New compliant bench
5. New accessible drinking fountain and water bottle filling station
6. Complete construction of new restroom

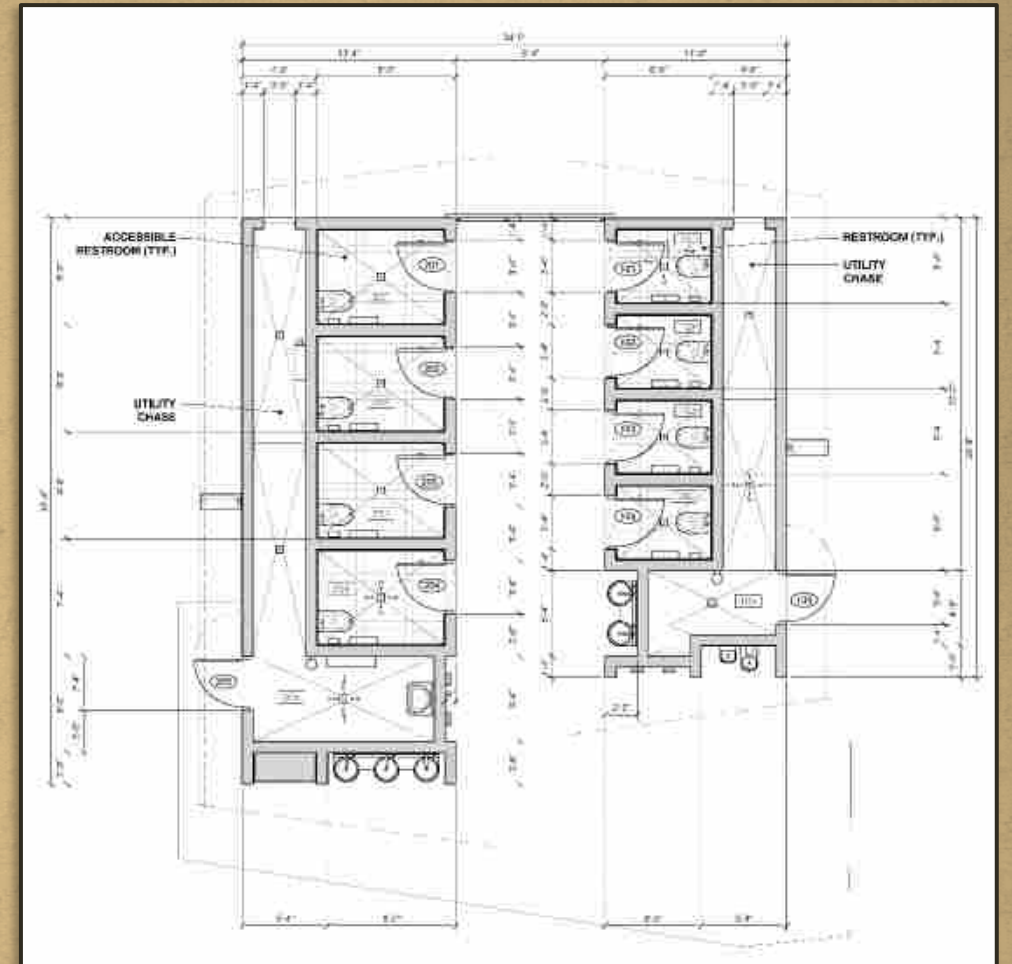
Comfort Station Components:

- Eight single-user toilet rooms (four accessible/family and four standard) and serviceable utility chases
- Outdoor queuing, handwashing/drying, baby changing station, drinking fountain/bottle filler, and security lighting

- Total = 750 gross square feet

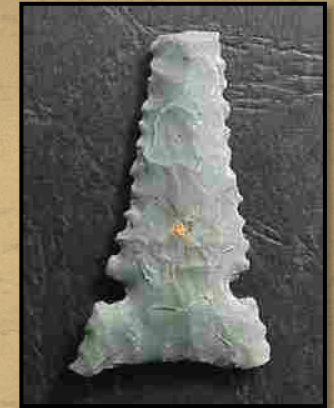
Hearth Feature

The oldest documented Native American site in TPSNR dates to before 8,000 years ago. The radiocarbon date record shows an almost uninterrupted use of the area by the Kumeyaay and their ancestors up until around 200 years ago. Typical features and artifacts include fire-affected rock clusters (hearths), stone tools and tool making scatters, shell middens, and various other resource procurement and processing workstations.
